3. REPORT TITLE		
DEVELOPMENT OF NEW CORROSION INHIBITORS AND ADHESION PROMOTERS		
4. DESCRIPTIVE NOTES (Type of report and inclusive dates)		
Final Report, Jan. 4, 1971 through Jan. 3, 1972

DEVELOPMENT OF NEW CORROSION INHIBITORS AND ADHESION PROMOTORS

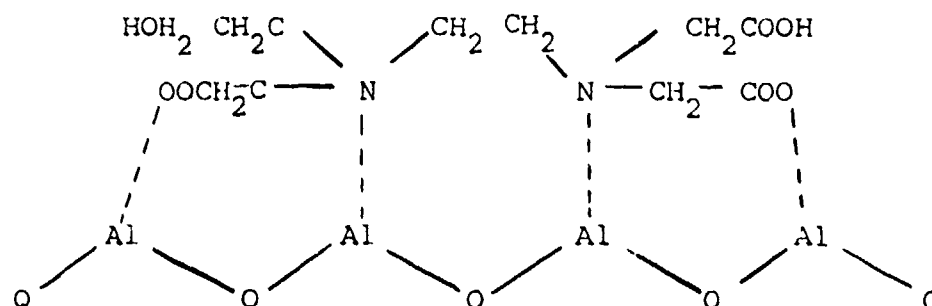
improved paint adhesion because of the uncoordinated organic groups of the surface-bound chelating agents, e.g. the hydroxyethyl groups in the structure below. A number of polydentate organic compounds are known which provide a wide variety of metal-binding (coordinating) groups, solubility characteristics, thermodynamic stabilities and metal-ion selectives.

Metal substrate HEDTA "chelate"

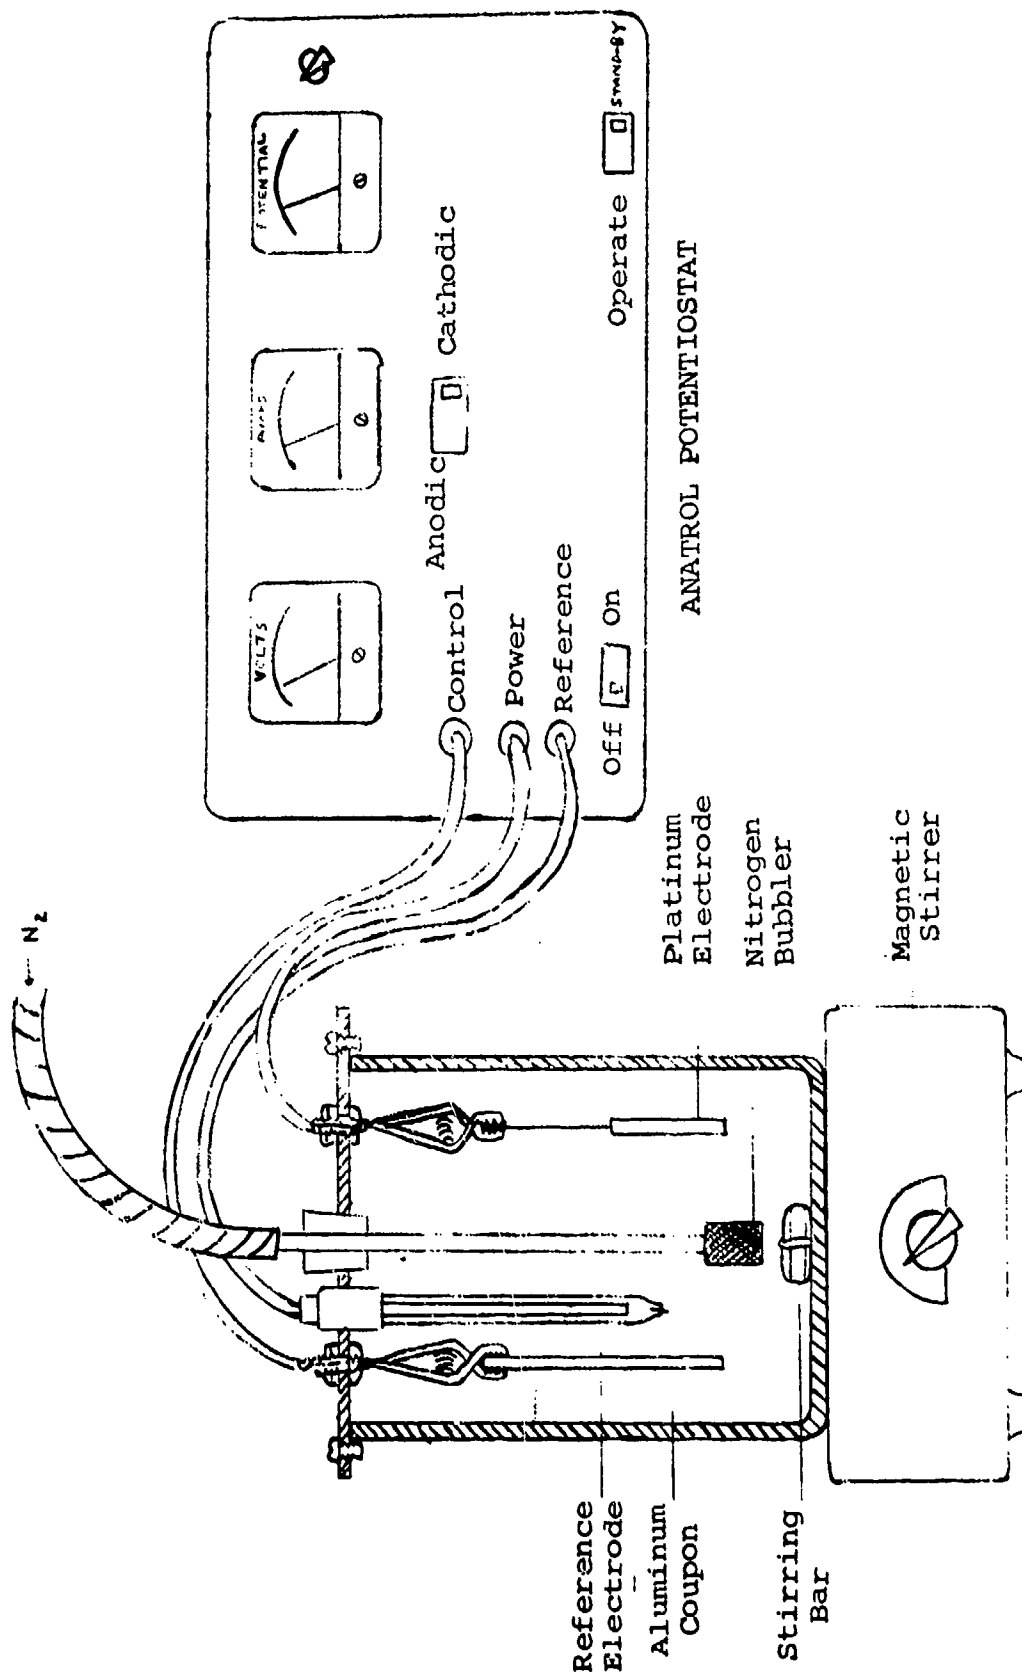
Figure 3
Experimental Set-up For Polarization Studies

Cathodic and anodic polarization studies were carried out on the test coupons which had been treated with the candidate chelating agents. The experimental procedure consisted of measuring the currents obtained as a function of the controlled potential applied. A model 4100 Anotrol Research Potentiostat was used. The electrochemical cell for the study consisted of a platinum counter electrode, the test coupon and saturated calomel electrode. All measurements were made at room temperature in an electrolyte medium of 3.5% aqueous sodium chloride. The medium solution was stirred vigorously by means of a magnetic stirrer. The control potential was varied from -2.6V to +2.6V during the course of the polarization study. A schematic diagram of the experimental set-up is illustrated in Figure 3. The controlled potential was varied manually and the cathodic and anodic polarization behavior of the test coupon investigated by measuring the current at each potential.

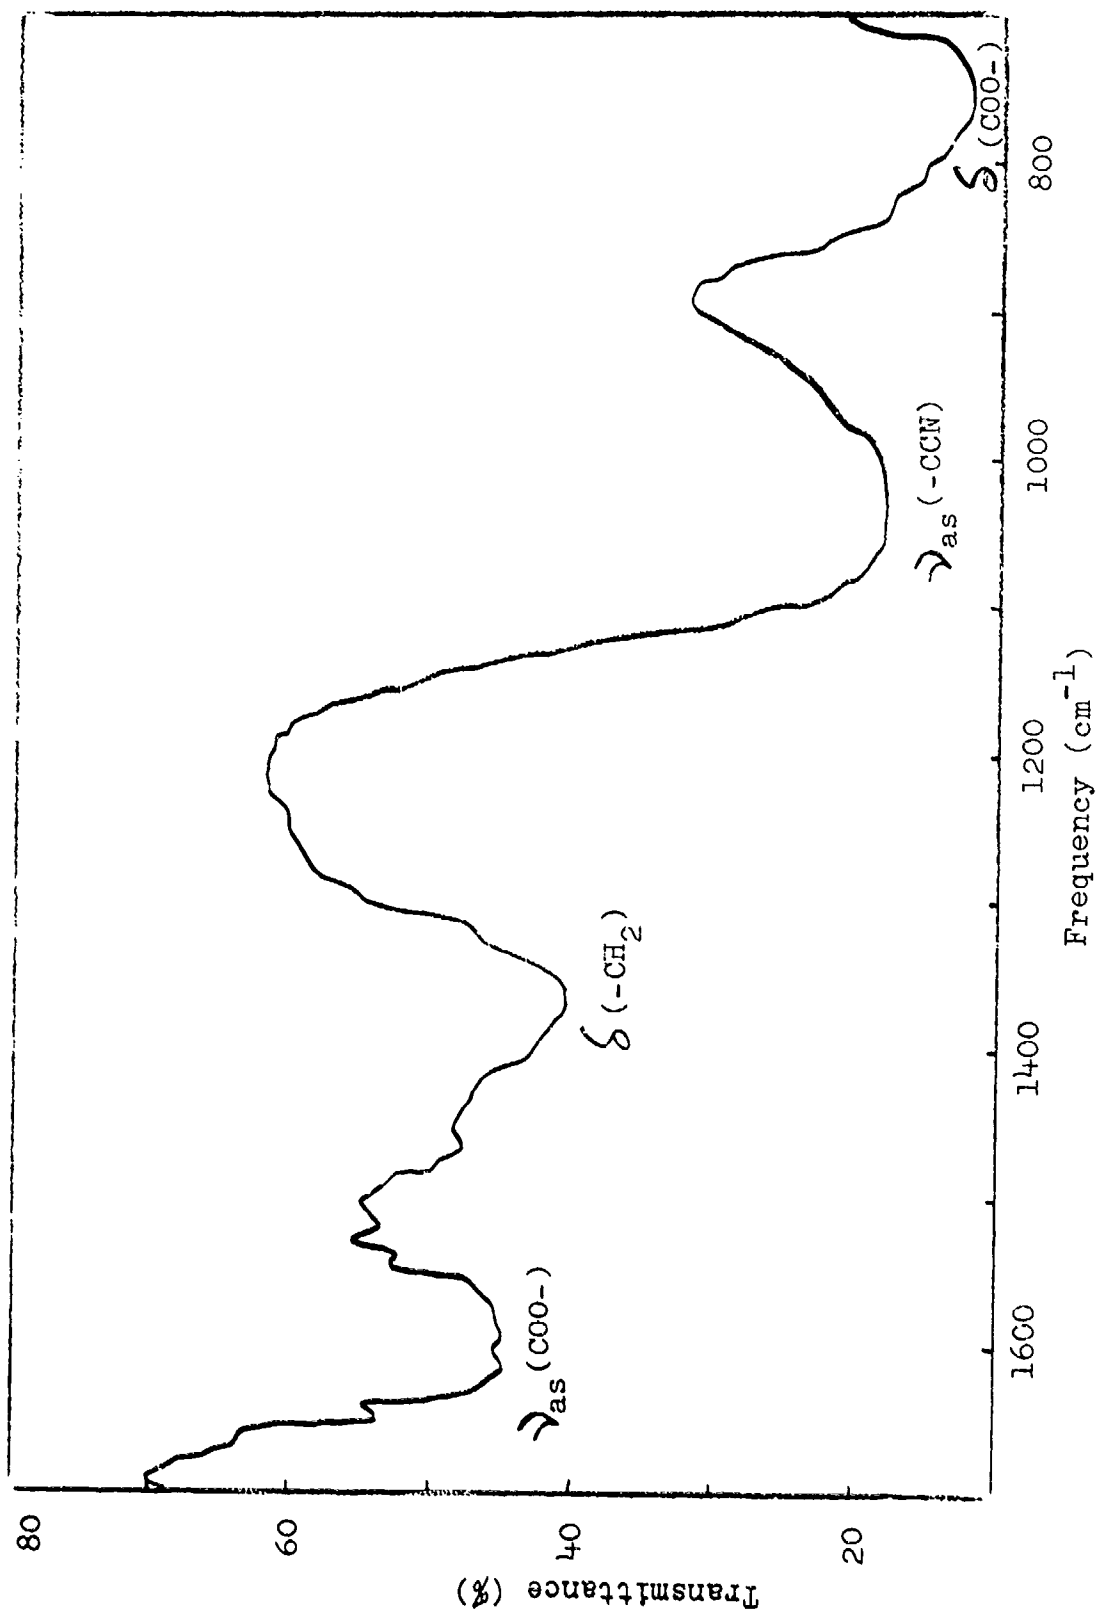
Figure 4. Reflectance IR Spectra of DTPA-Treated Aluminum Surface

The satisfactory specimens (belonging to the aluminum alloys) included those which had been treated with amino-carboxylic acids such as DTPA, EDTA, HEDTA and IMDA. Further, the coupons treated with some of the aminophosphonates belonging to the DEQUEST series gave satisfactory reflectance spectra. Figures 4,5,6,7 show the reflectance spectra of aluminum surfaces treated with DTPA, EDTA, CHELON-DHG (Dihydroxyethylglycine) and hydontoic acid in the frequency range of $600-1700\text{ cm}^{-1}$. A discussion of the significant spectral peaks and their functional group assignments is presented.

The reflectance IR of these systems showed spectral peaks at the following frequencies (cm^{-1}): 3200 (broad), 2060-2080, 1570-1600, 1360, 1030, 760-770 and 390. The peak at 1570-1600 is attributed to the antisymmetric carbonyl stretching frequency of the carboxylate group, and the one at 1360 to the C-H bending mode of the $-\text{CH}_2$ grouping. The peak at 1030 is $-\text{C}-\text{C}-\text{N}$ -symmetric stretching of the $\text{N}-\text{CH}_2-\text{CH}_2-\text{N}$ grouping and the one at 760 is the deformation frequency of $-\text{COO}^-$. The fact that the IR-frequencies of all the functional groups of the amino-carboxylate compounds were found to be present in the reflectance spectra of the

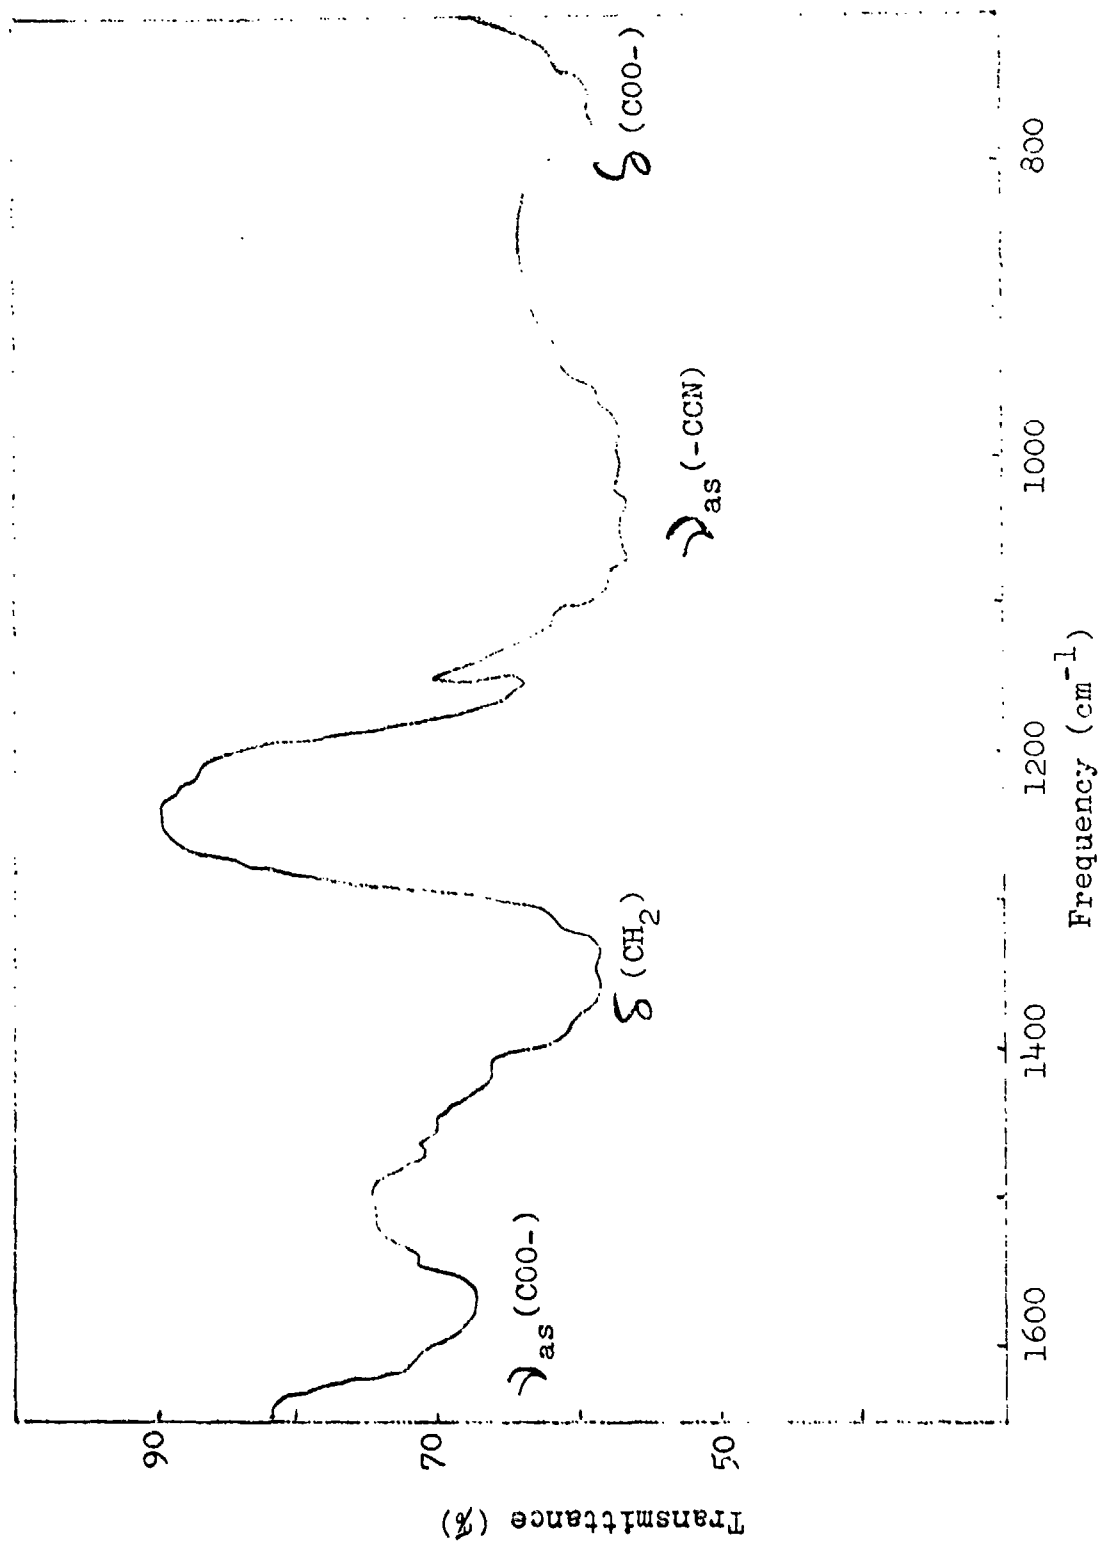
Figure 5. Reflectance IR Spectra of EDTA-Treated Aluminum Surface

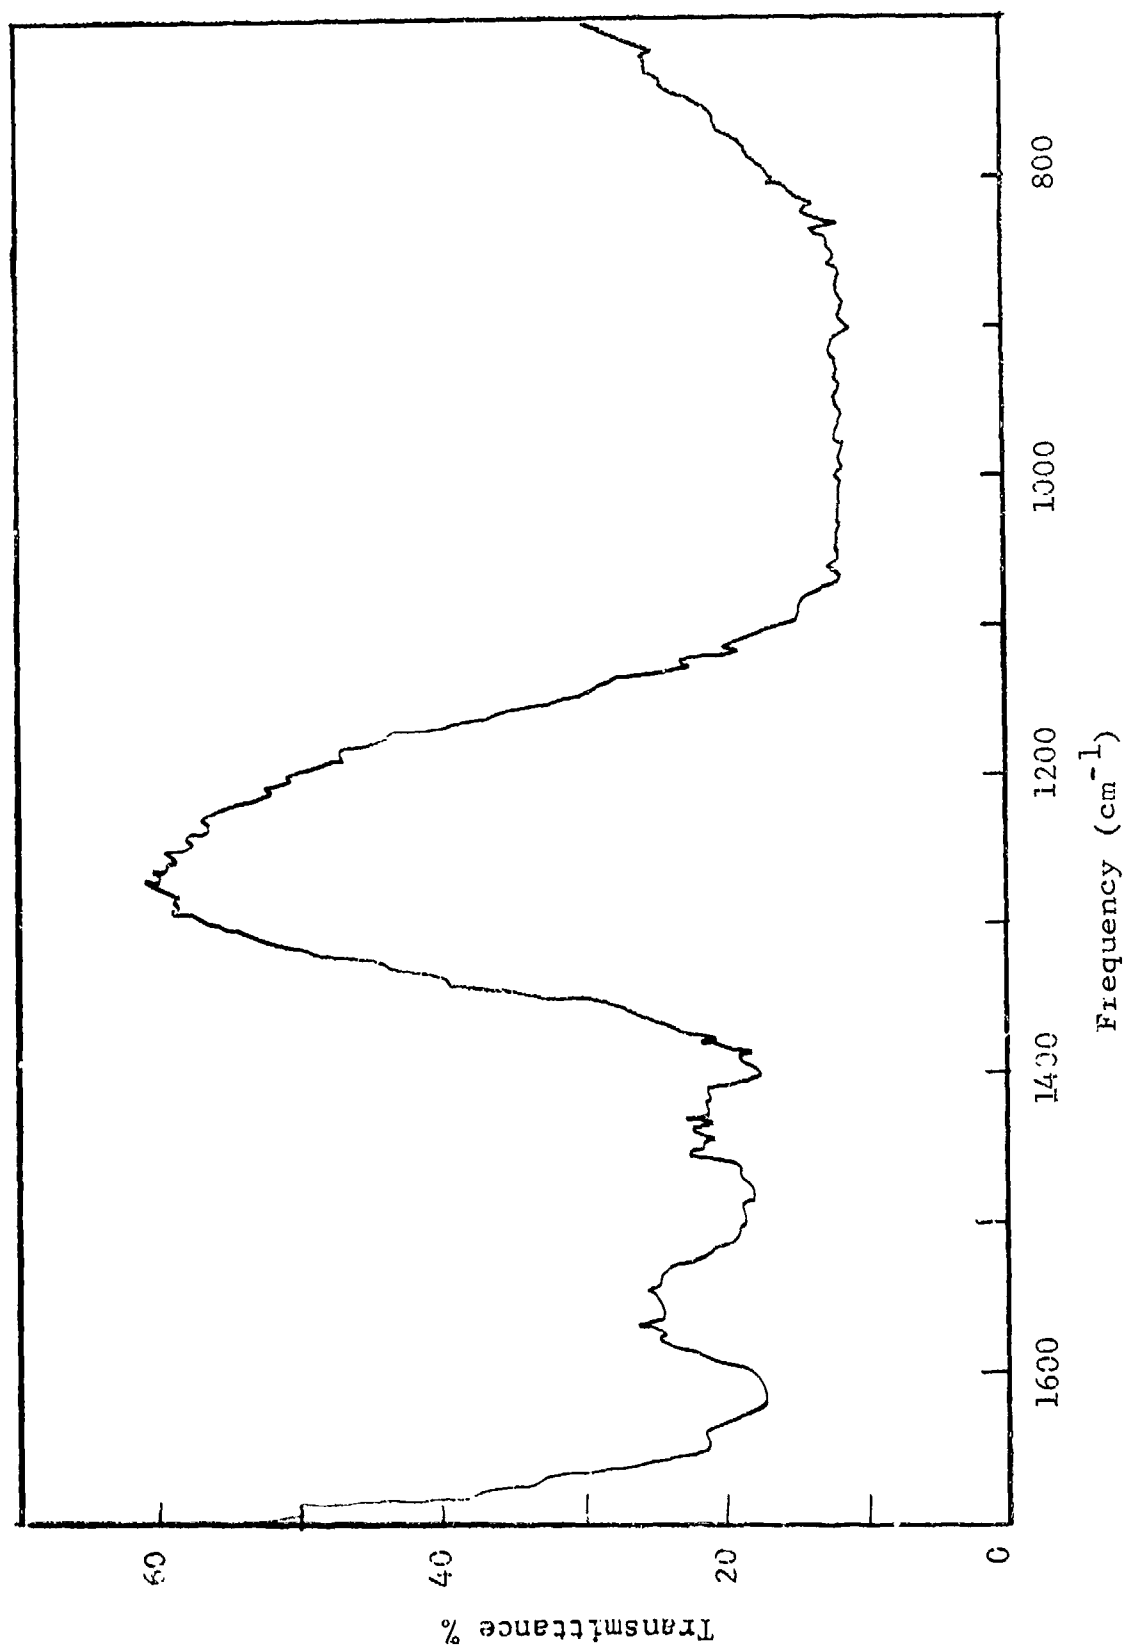
Figure 6. Reflectance IR Spectra of CHELON-DHG Treated Aluminum Surface

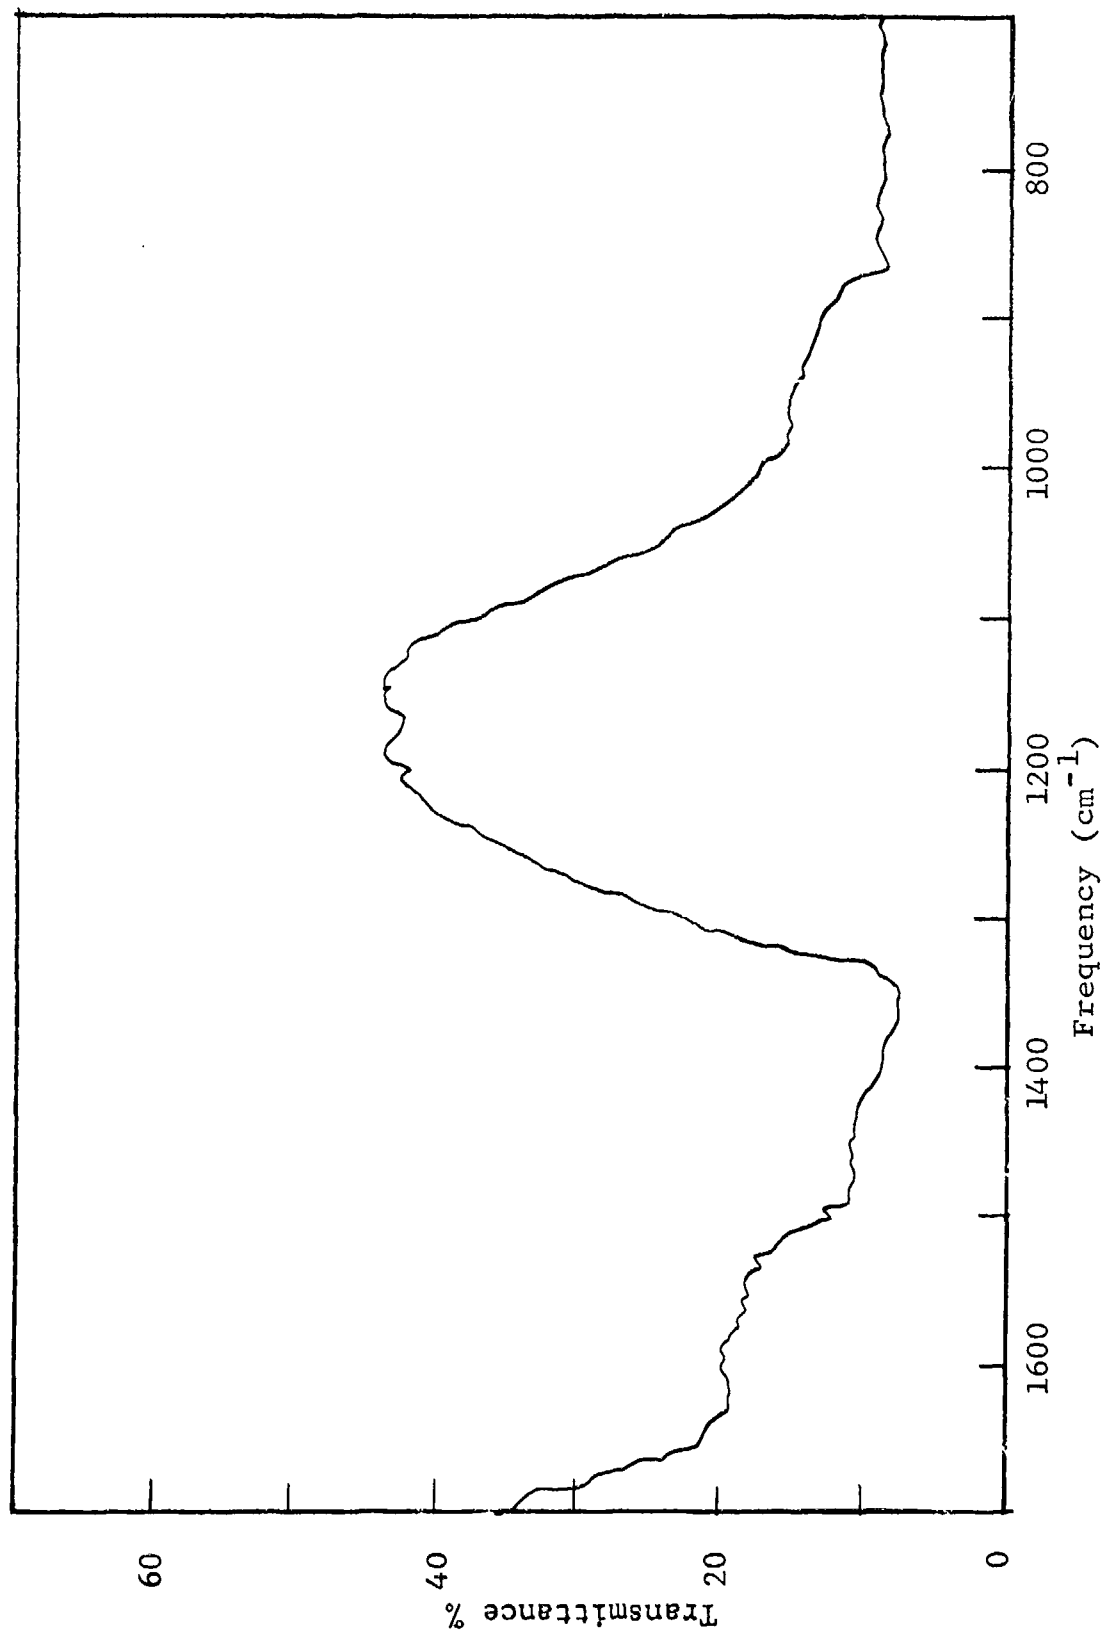
Figure 7. Reflectance IR Spectra of HYDANTOIC ACID Treated Aluminum Surface

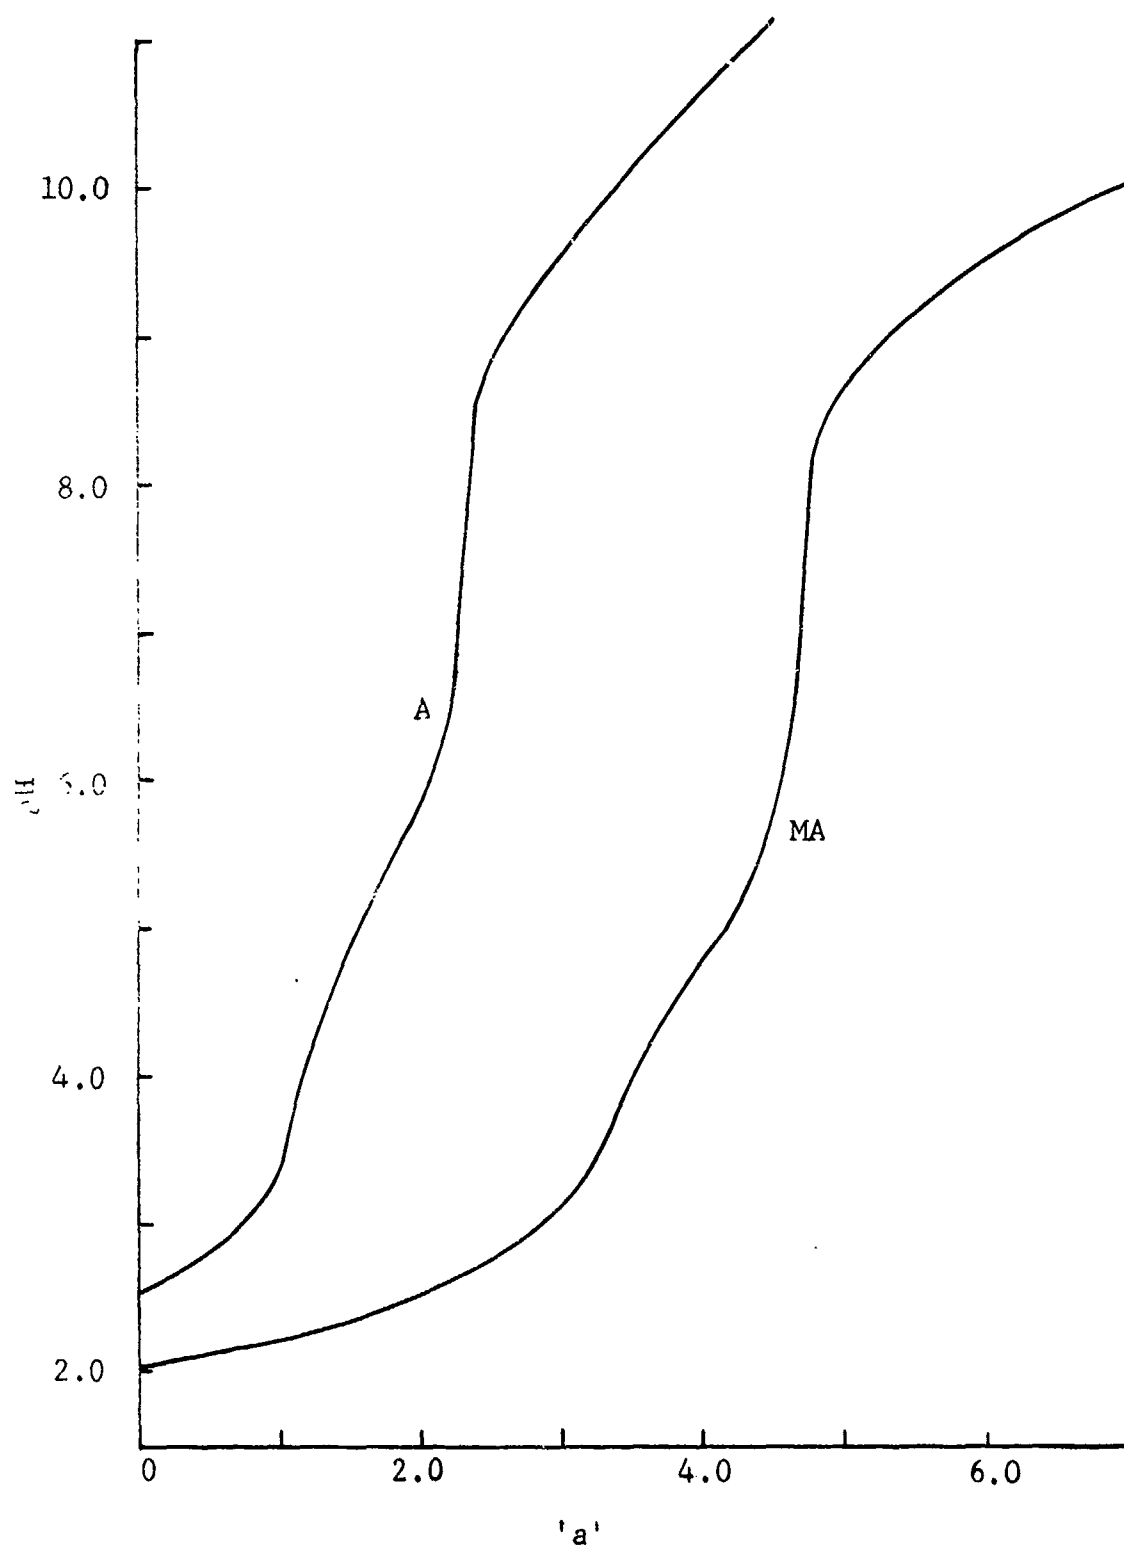
Figure 8
 Chelation of Al(III) With HEDTA A = HEDTA;
 MA = 1:1 Al(III) - HEDTA System. a = No. of
 Moles of Base Per Mole of Ligand and Al(III).

Potentiometric titration curves for the reactions of aluminum ion with (i) hydroxyethylethylenediaminetriacetic acid (HEDTA), (ii) sulfosalicylic acid (SSA), (iii) succinic acid (SA), (iv) diethanolaminemonomethylenephosphonic acid (DEMPA) are presented in Figures 8, 9, 10 & 11. In these plots, the abscissa represents 'a', the number of moles of base added per mole of the chelating agent or the total metal salt, and the ordinate represents the measured pH values.

Consideration of the Al(III)-HEDTA system with inflections at 3 and 4 equivalents of base (Figure 8) indicates that the aluminum ion interacts strongly with all the three carboxylic acids of the chelating agent in pH range 2-4, and further reacts with the hydroxyl group in the pH range 4-7. It is valid to rationalize that the metal ion is bound by two amino-nitrogens, the three carboxylate oxygens and possibly by the hydroxyethyl group as follows:

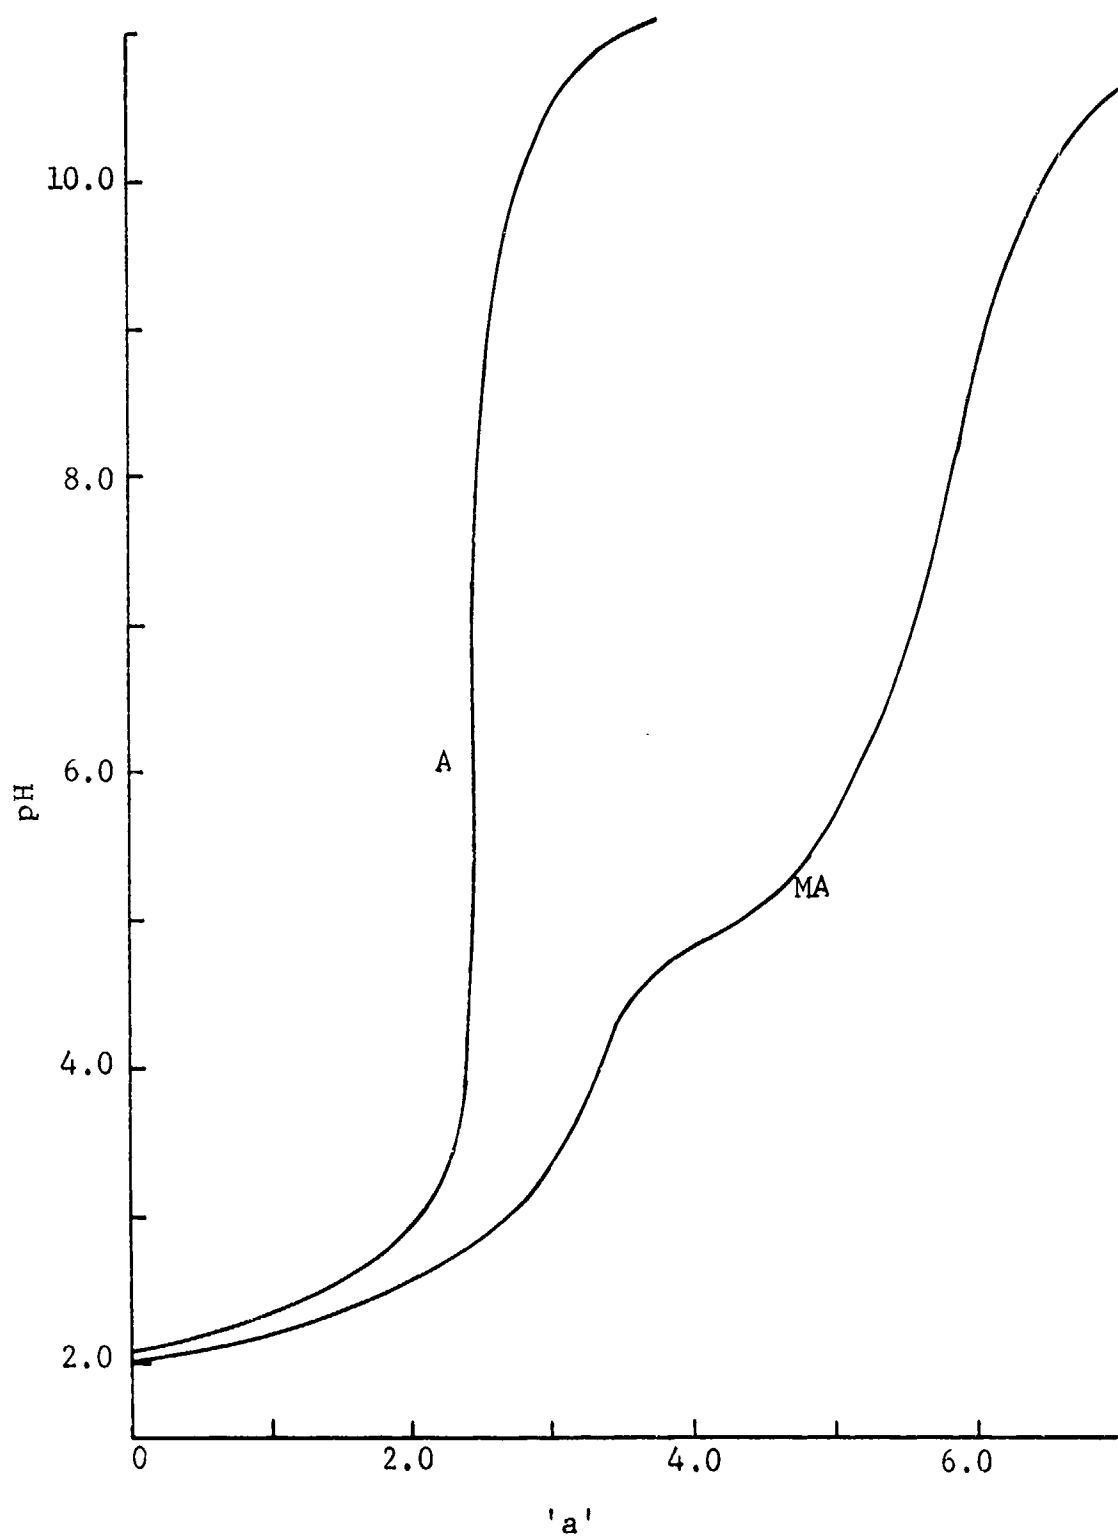
Interaction of Al(III) With SSA; A, Free SSA;
MA, 1:1 Al(III) - SSA System.

Figure 9 indicates that sulfosalicylic acid binds strongly with aluminum ion in the pH range 2-4 and that the carboxylic and the phenolic hydroxyl group are both involved in the metal binding. This is structurally illustrated below:

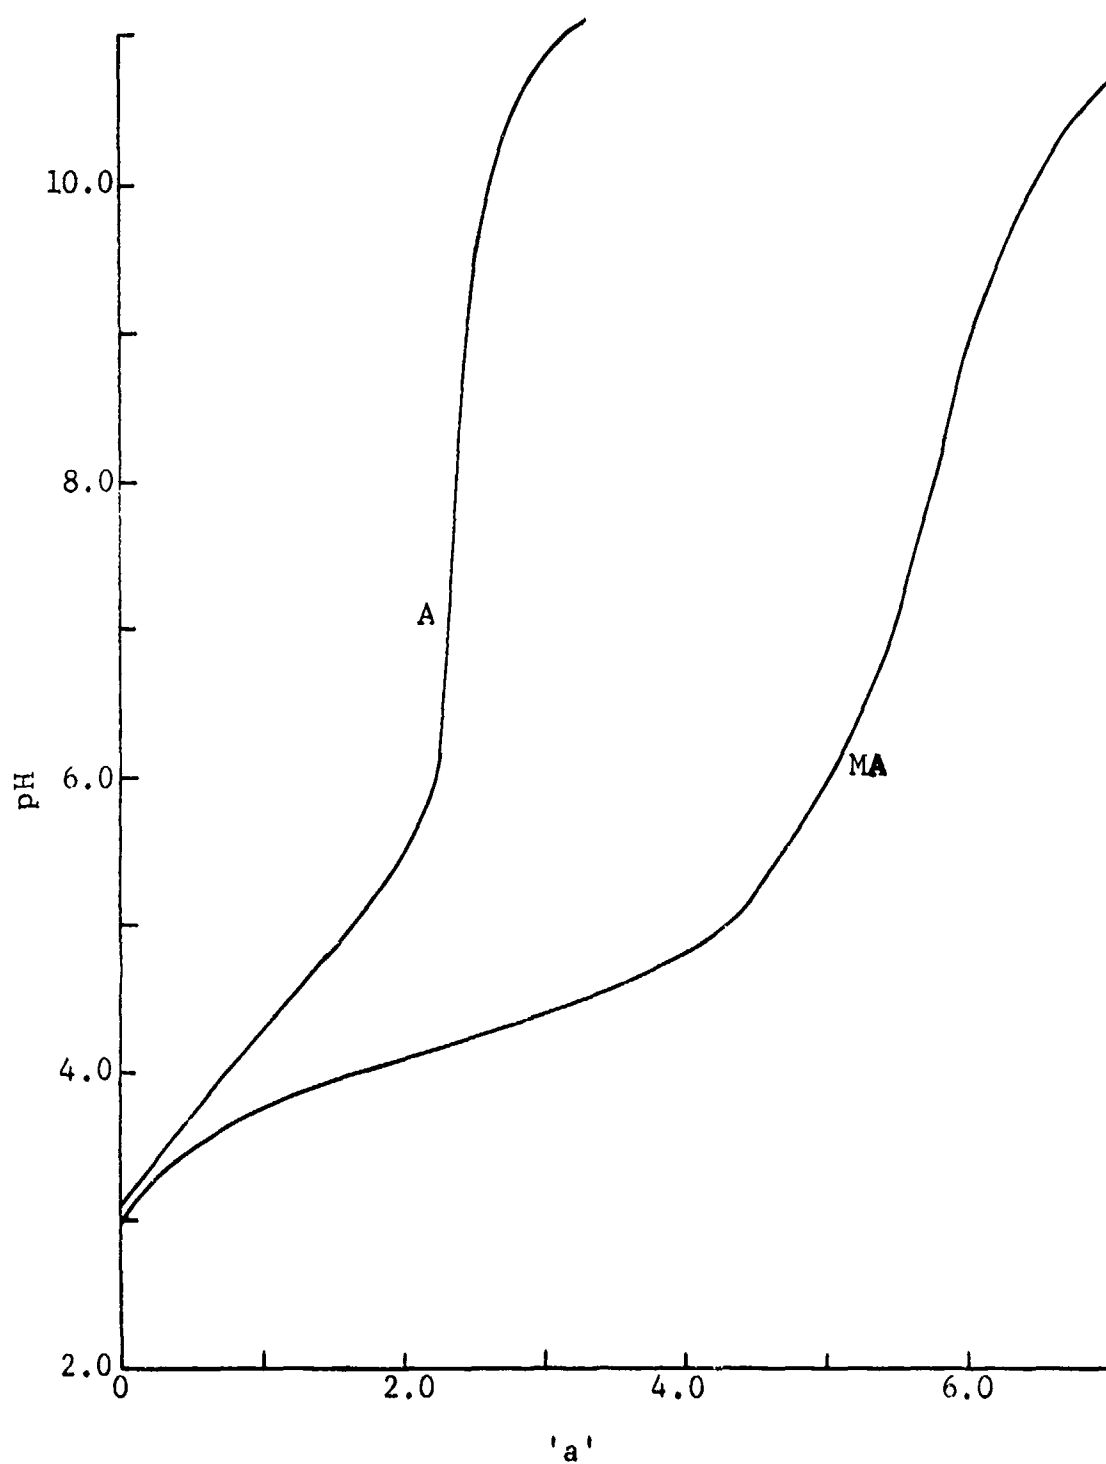
Figure 10

Interaction of SUCCINIC ACID With Al(III) Ion.
A, Free SUCCINIC ACID; MA, Al(III) - SUCCINIC
ACID (1:1) System.

Succinic acid, which is a simple dicarboxylic acid, does not exhibit strong binding tendency toward aluminum. The titration curve (Figure 10) indicates extensive hydrolysis of the metal due to weak chelation by mere carboxylate groups.

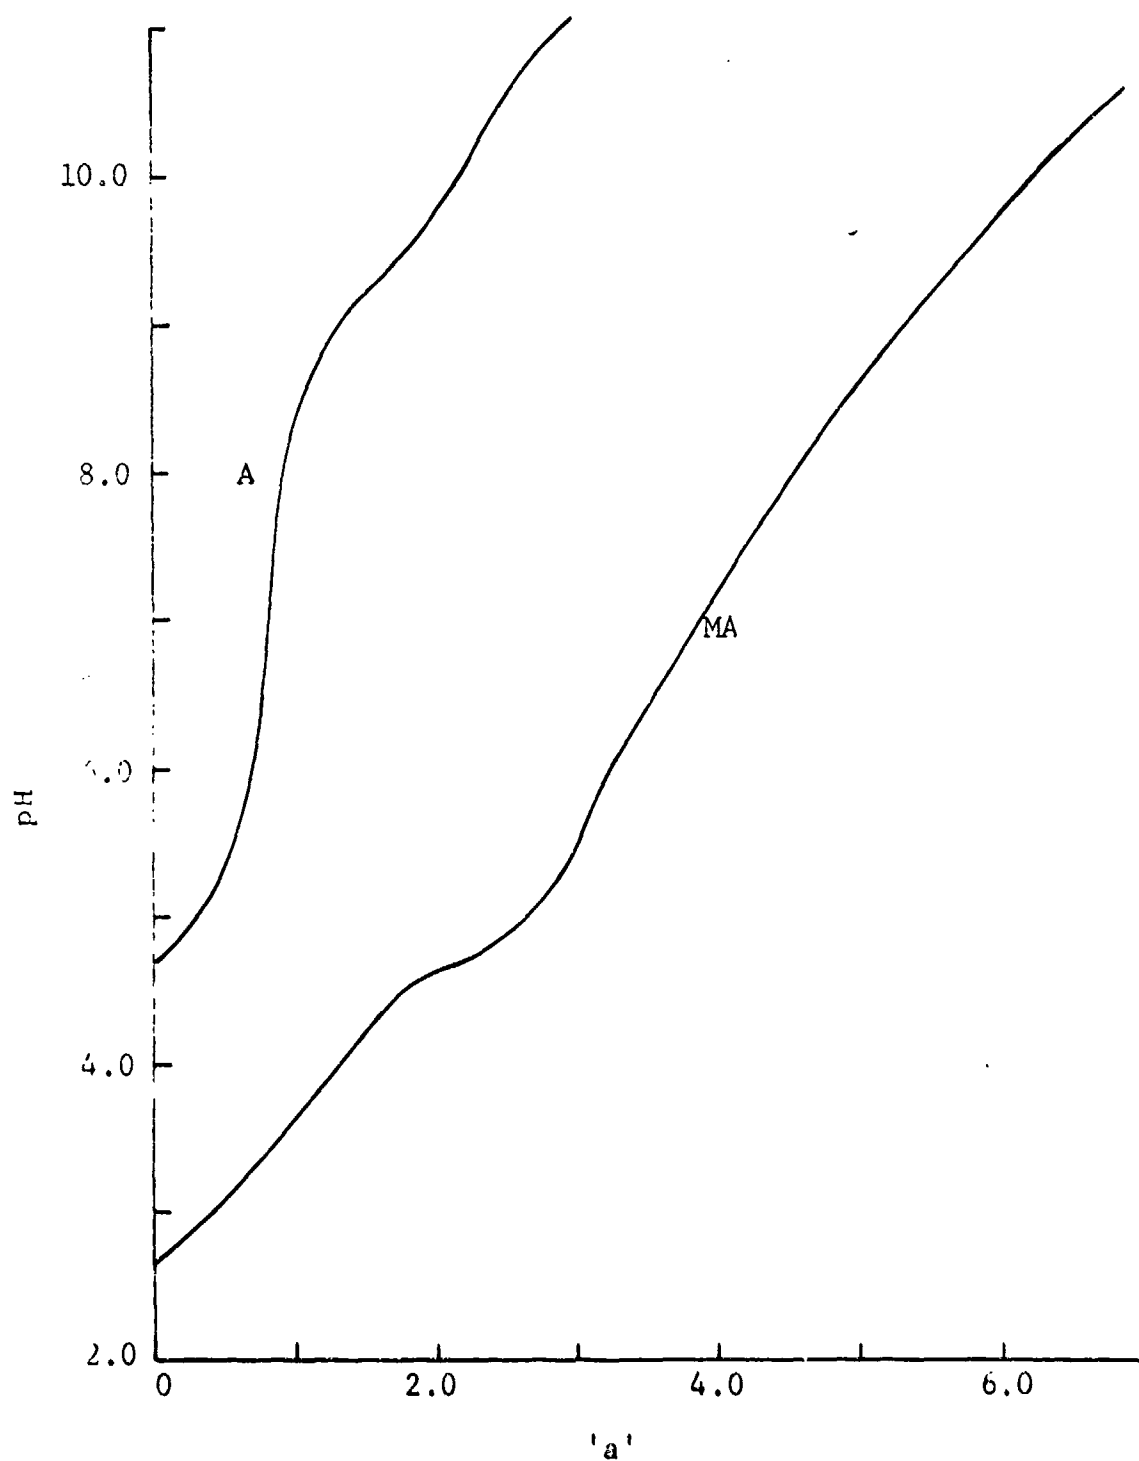
Figure 11

Chelation of Al(III) Ion With DEMPA;
A, Free DEMPA, MA, 1:1 Al(III) - DEMPA

Consideration of the titration curve of Al(III)-DEMPA system indicates that the metal ion is strongly chelated and that the phosphonate and one of the hydroxyethyl groups are involved in chelation. The coordinate-binding of aluminum by this chelating agent is illustrated by the following structure.

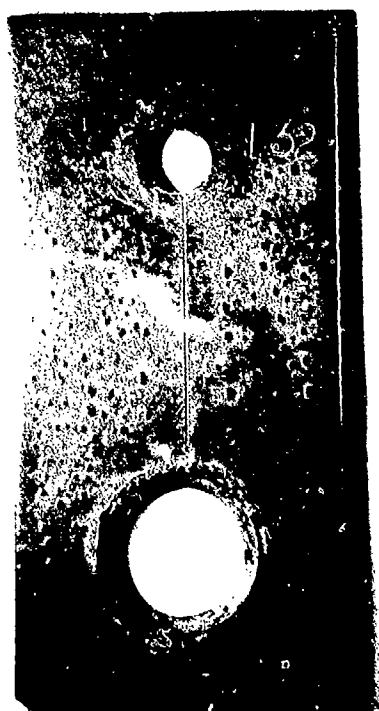
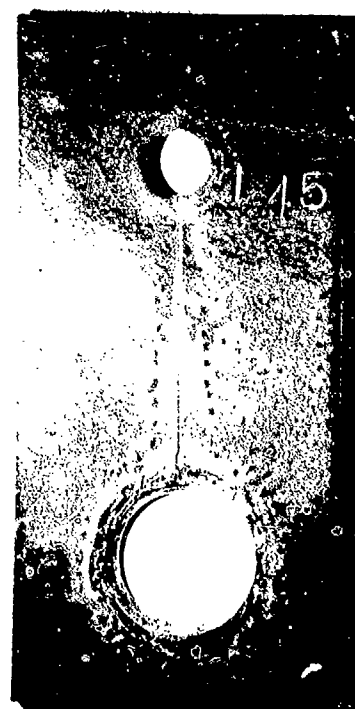
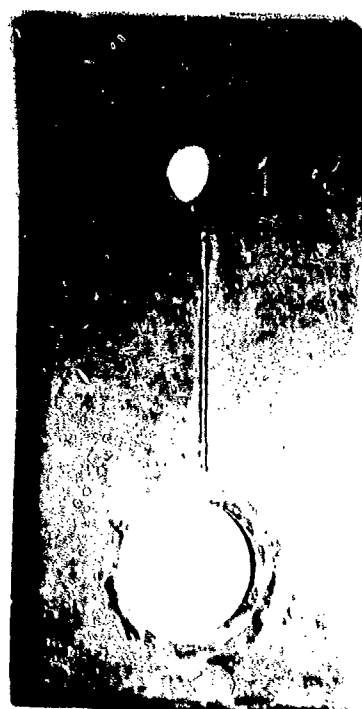
Figure 14

Stainless Steel #302; Pretreated with
CHELON-DHG; Primer Coated; Blister
Formation.

Stainless Steel #302; Pretreated with
Conventional CHEMRITE; Primer Coated;
Blister Formation

Stainless Steel #302; Pretreated with
Malic Acid; Primer Coated; Blister
Formed Lightly Along Edges Only

It should also be pointed out that blister formation on the paint film took place in a number of instances in the case of stainless steel and titanium after they had been exposed to salt solution spray for a few days. This phenomenon was noted both in the case of the conventional chromate-treated and some of the chelate-treated systems as is illustrated by the photographs (Figure 14). No corrosive damage occurred underneath the blisters and the blisters disappeared on removing the test coupons from the salt splash unit and drying. It will be necessary to determine, if possible, the conditions that favor such blister formation and to eliminate them in future studies.

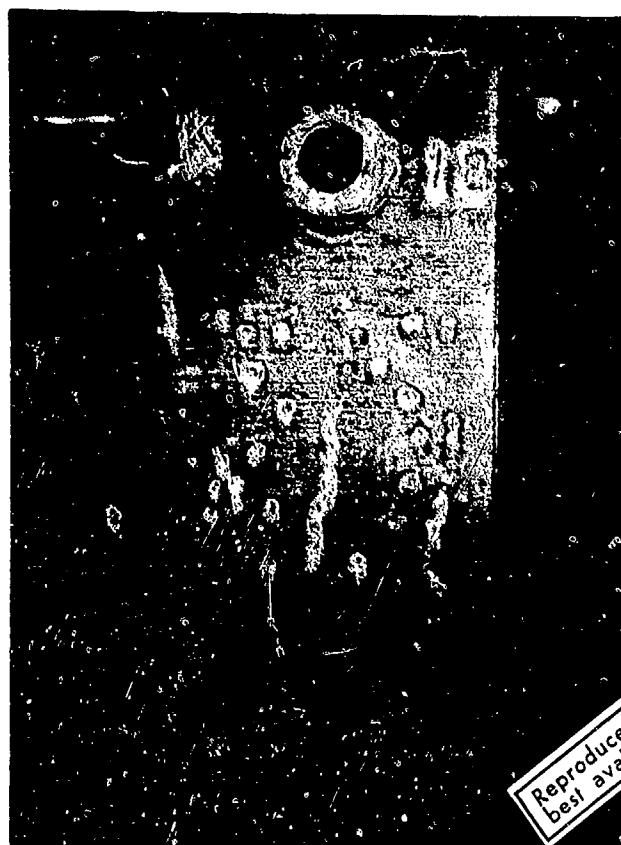
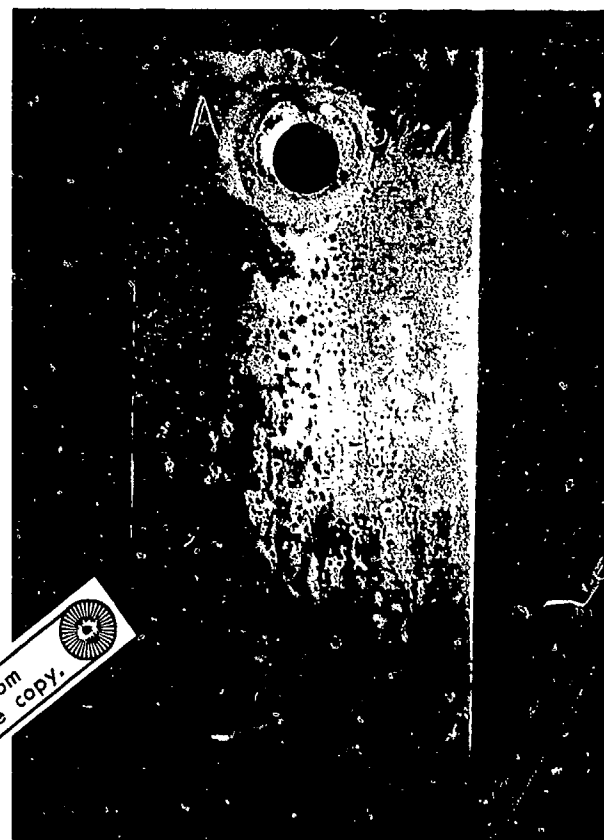
Figure 15

Corrosion of Aluminum Coupon
Pretreated with p-aminobenzoic
Acid; Exposed to 96 Hours of
Salt Spray

Corrosion of Aluminum Coupon
Pretreated with CHEMRITE; Exposed
to 96 Hours of Salt Spray

Although the evaluation of corrosion characteristics of the chelate-treated coupons was carried out essentially only after they had been primer-coated with epoxy primer, a few rapid corrosion tests were also conducted on unprimed test coupons. This series of experiments were undertaken in order to evaluate the nature of corrosion protection afforded by the chelating agent. Aluminum 7075 and 2024 alloy coupons were used and a few selected chelating agents
